Gulfstream G200

NUMBER 200-57-426, Revision 2

WINGS (ATA 57) – FLAPS – FAIRING SEAL
REPAIR

FEBRUARY 01, 2023

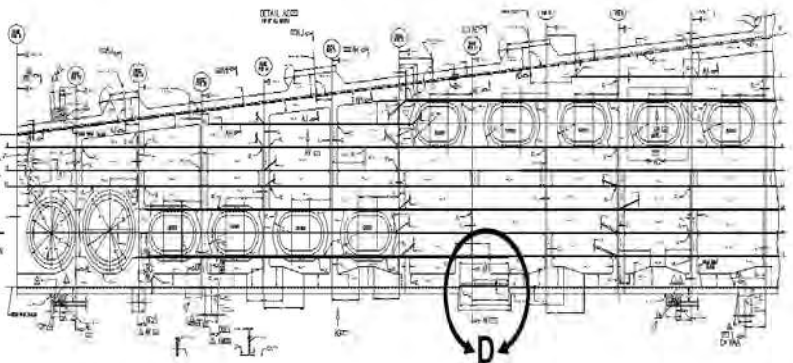
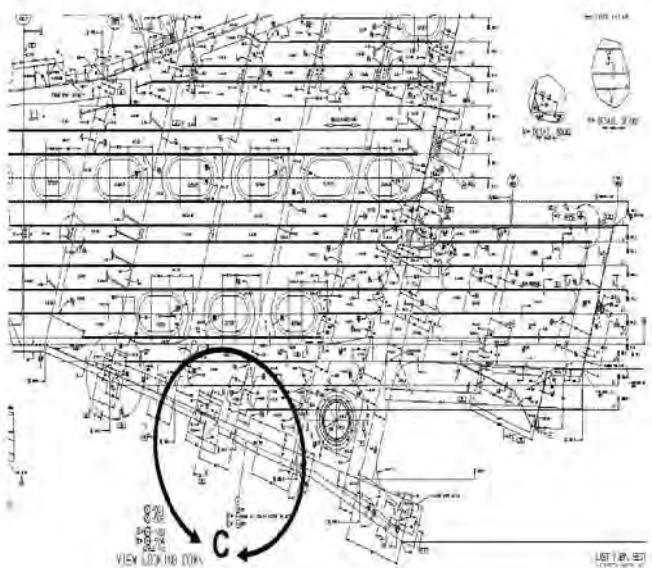
Wing Fairing Sealing Repair
Figure 1 Sheet 1 of 3

Left and right wing flap fairing debonding and corrosion discovered at lower skin of Rib 3 and Rib 11.

12. Inspect the area for moisture and contaminants, and remove if present before resealing.
13. Reseal fillet seal using sealant PR1750 or PR1776 or equivalent on both inner and outer sides of fairings. Refer to Figure 1.
14. Ensure work area is clean and clear of foreign objects (FOD).
15. Apply external electrical power to aircraft. Refer to AMM, Chapter 20.
16. Retract flaps. Refer to AMM, Chapter 27.
17. Remove electrical power from aircraft. Refer to AMM, Chapter 20.
18. Record compliance with this service bulletin in the aircraft's permanent maintenance records and return aircraft to flight status.
19. Report compliance with this service bulletin to Gulfstream Computerized Maintenance Program (CMP) by uploading the attached service reply card, along with the CMP task card(s) sign-off using MyGulfstream, MyCMP Document Upload or e-mail to fax@campsystems.com.

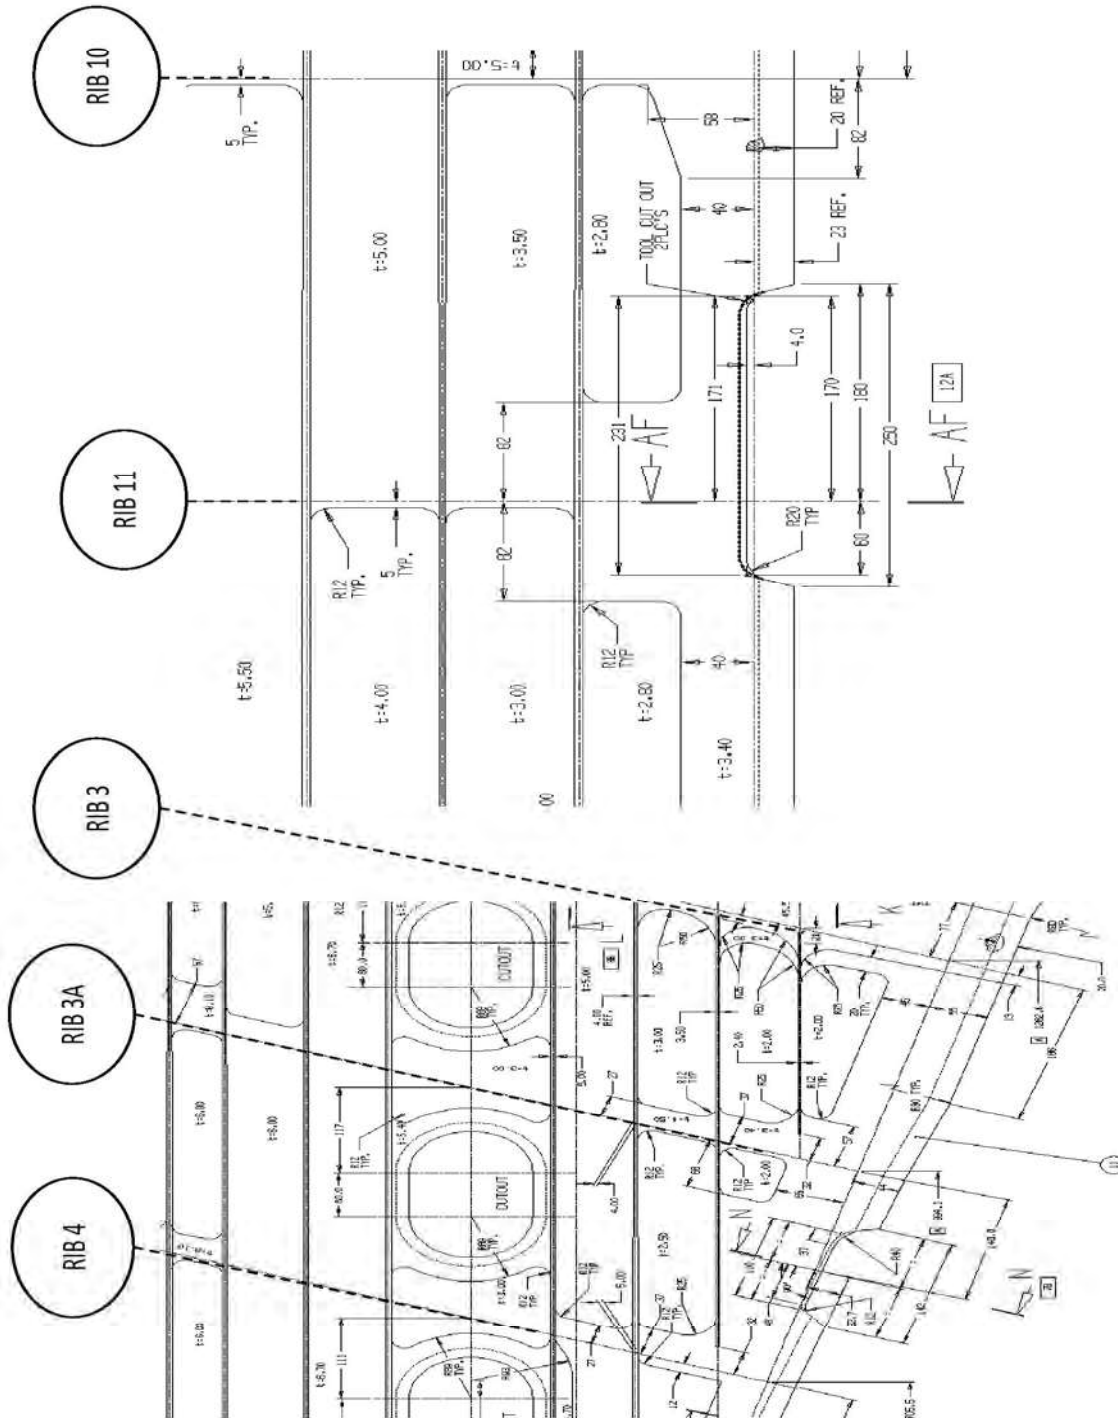
Wing Fairing Repair Area
Figure 1 Sheet 2 of 3

- A. If cracks were discovered, report to Gulfstream.
 - B. If no cracks were discovered, proceed to the next step.
8. If it was necessary to remove corrosion, then check the remaining skin (or doubler if installed) thickness with 1/2 inch grid as follows; Refer to Figure 1.

- A. Review the thickness measurements at each of the four fairing installation locations. For any fairing installation location with one or more grid squares with thickness reduction of greater than 10%, report the findings to Gulfstream prior to performing the repair in Appendix II. Following completion of the repair and proceeding to Step 11.

- (1) For 10% thickness reduction calculating, refer to nominal skin thickness values. Refer to Figure 1.
 - B. If no grid or square presents a skin thickness reduction of 10% proceed to the next step.

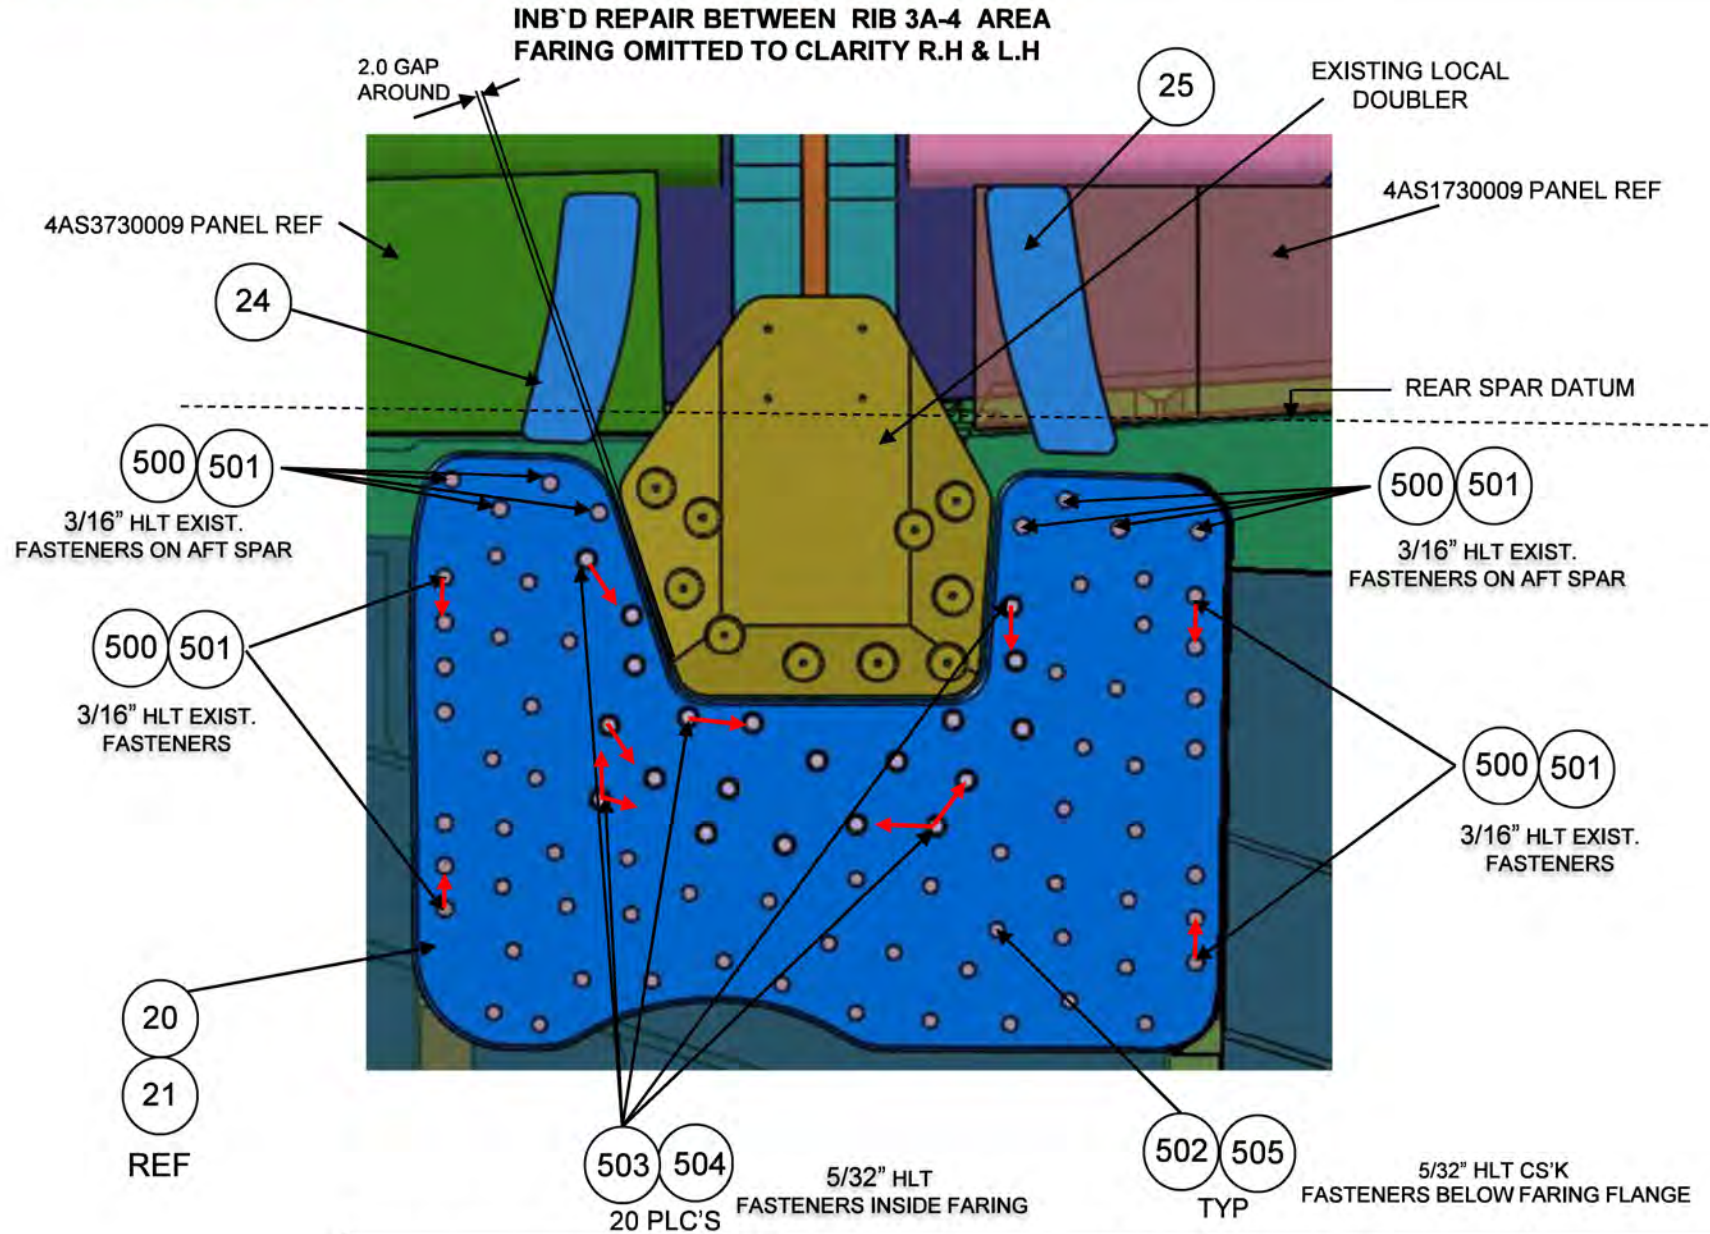
INB'D REPAIR BETWEEN RIB 3A-4 AREA FOR L.H & R.H OPP
VIEW LKG DOWN ON LOWER SKIN

2. FOR REPAIR CORROSION ON SKINS P/NS 4AS1710301-007/-008 INB'D (RIB 3A L.H & R.H) & OUTB'D (RIB 11 L.H & R.H)

2.1. BRUSH ON REWORK AREAS ON SKIN AFTER BLENDING ALODINE PER PS233200 AND EPOXY PRIMER PER PS243900 CLASS 2.

2.2. FILL GAPS BETWEEN BLENDED SKIN AREA & ITEMS 20-27 PER NOTE 7 OF APL.

2.3. INSTALL ITEMS 20-27 WET PER NOTES 1 & 8 OF APL AS SHOWN IN SHEETS 12-17.
